**Jefferson Proving Ground  
South of the Firing Line**

**Final Asbestos Survey Summary Report**

**Volume III  
(Buildings 230 through 475)**

**September 1993**

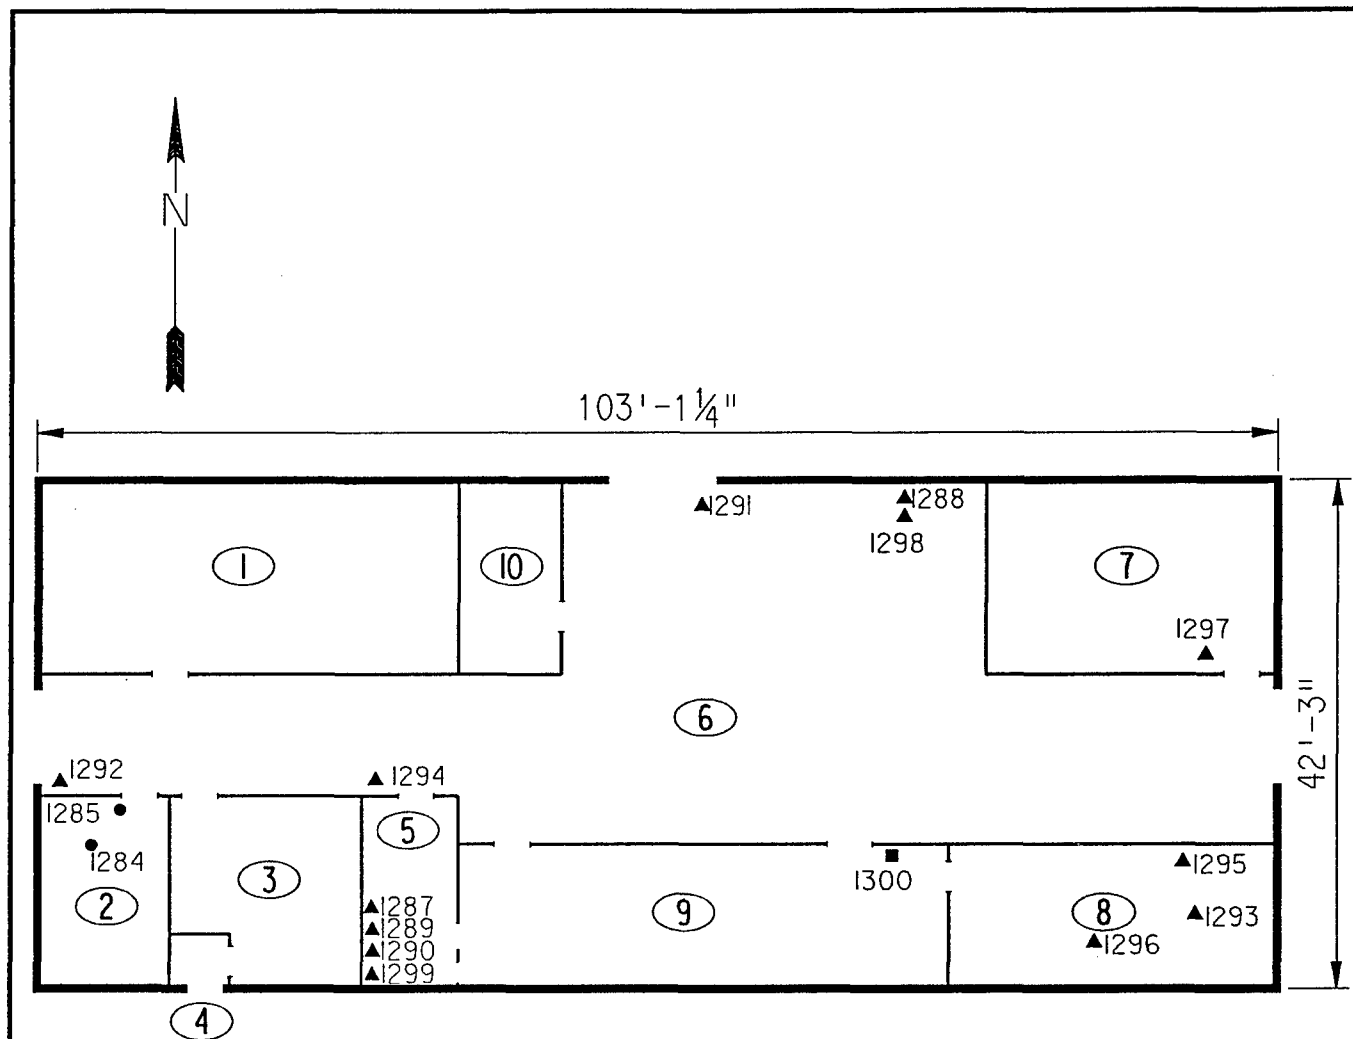
- 80 linear feet of corrugated cardboard pipe insulation ("aircell"). This insulation was observed to be in fair to good condition with evidence of significant physical damage or material deterioration in Room 5 (women's rest room).

- 10 areas of packed "fitting" insulation on pipes otherwise insulated with corrugated cardboard material. This insulation was observed to be in fair to good condition with evidence of localized physical damage or material deterioration in Room 5 (women's rest room).

- #1 Entire Structure: **ACM Assessment Rating B**, there is significantly damaged friable ACM in an occupied area.

Areas of damage were identified in the ladies rest room (Room 5). Pipe insulation and fitting insulations need to be repaired immediately. The condition of the ACM and the occupancy and utilization of these areas by personnel present the potential for creating an airborne asbestos hazard.

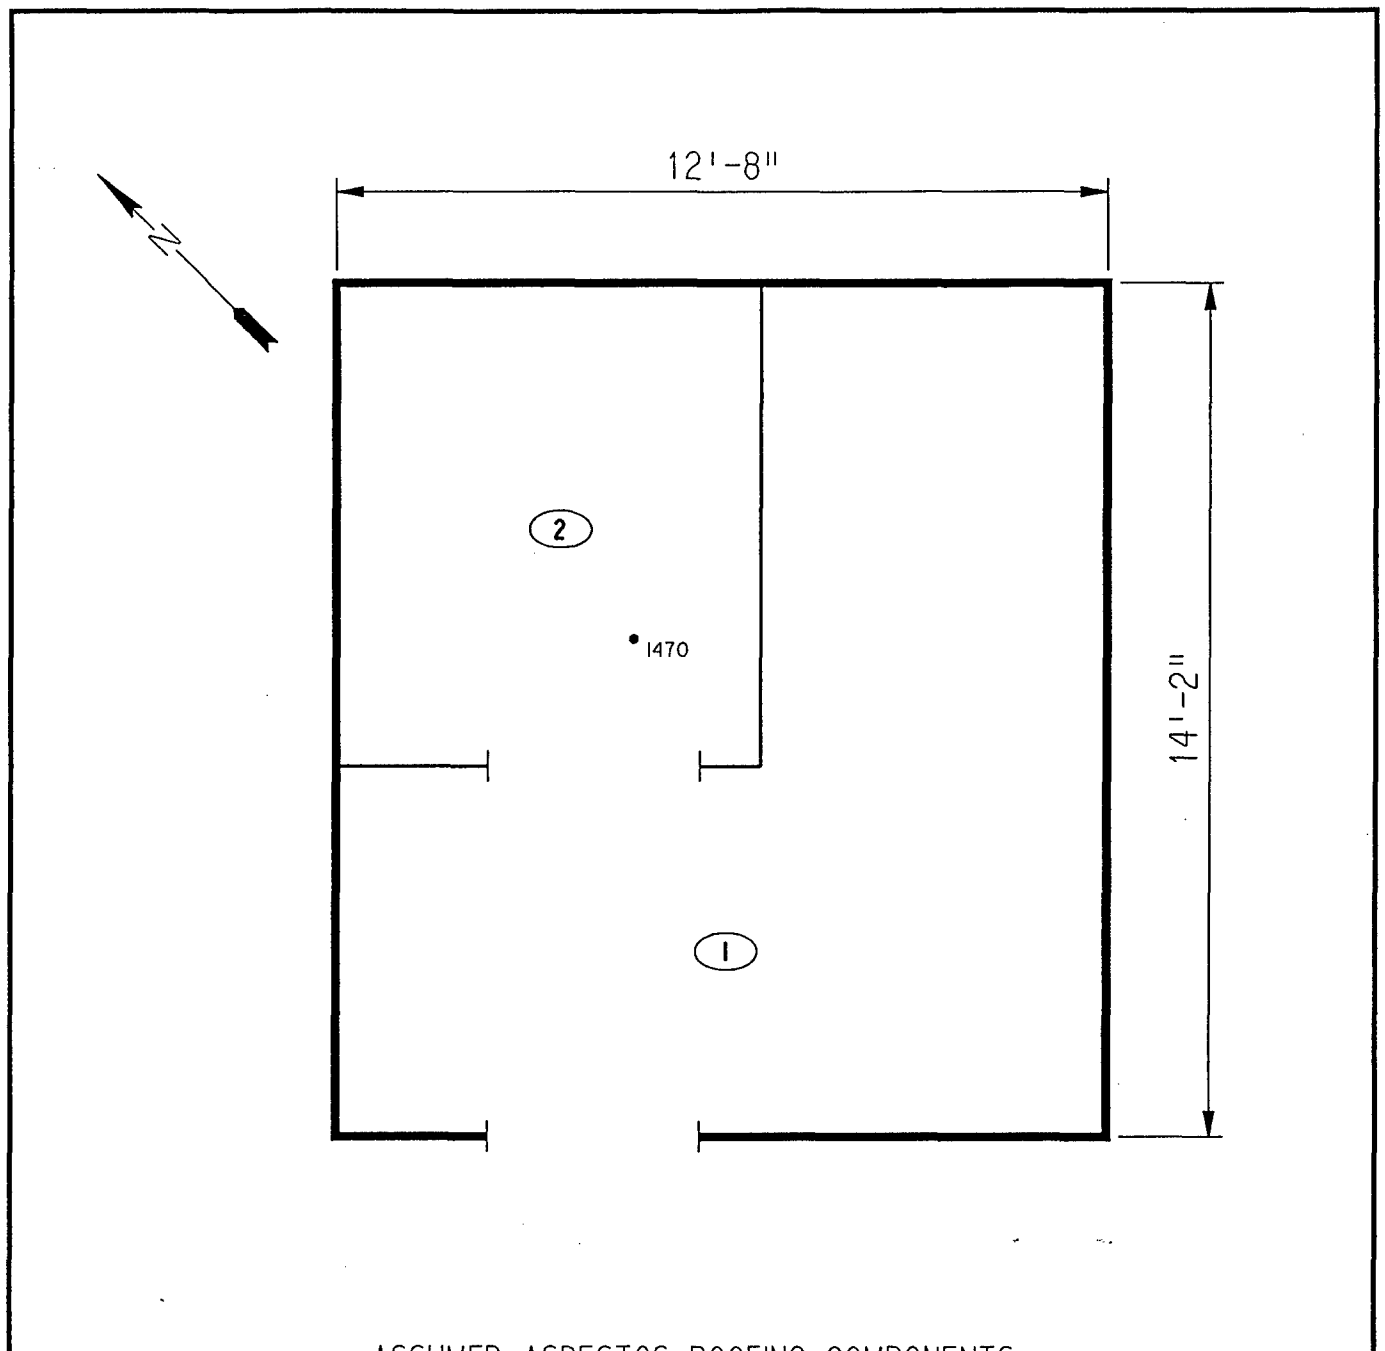
- 225 square feet of cement board ("Transite") exterior roofing shingles. These shingles were observed to be in generally good condition with minor areas of isolated damage.

The general condition of ACM present was observed to be good with the noted exceptions above. ACM observed was nonfriable.

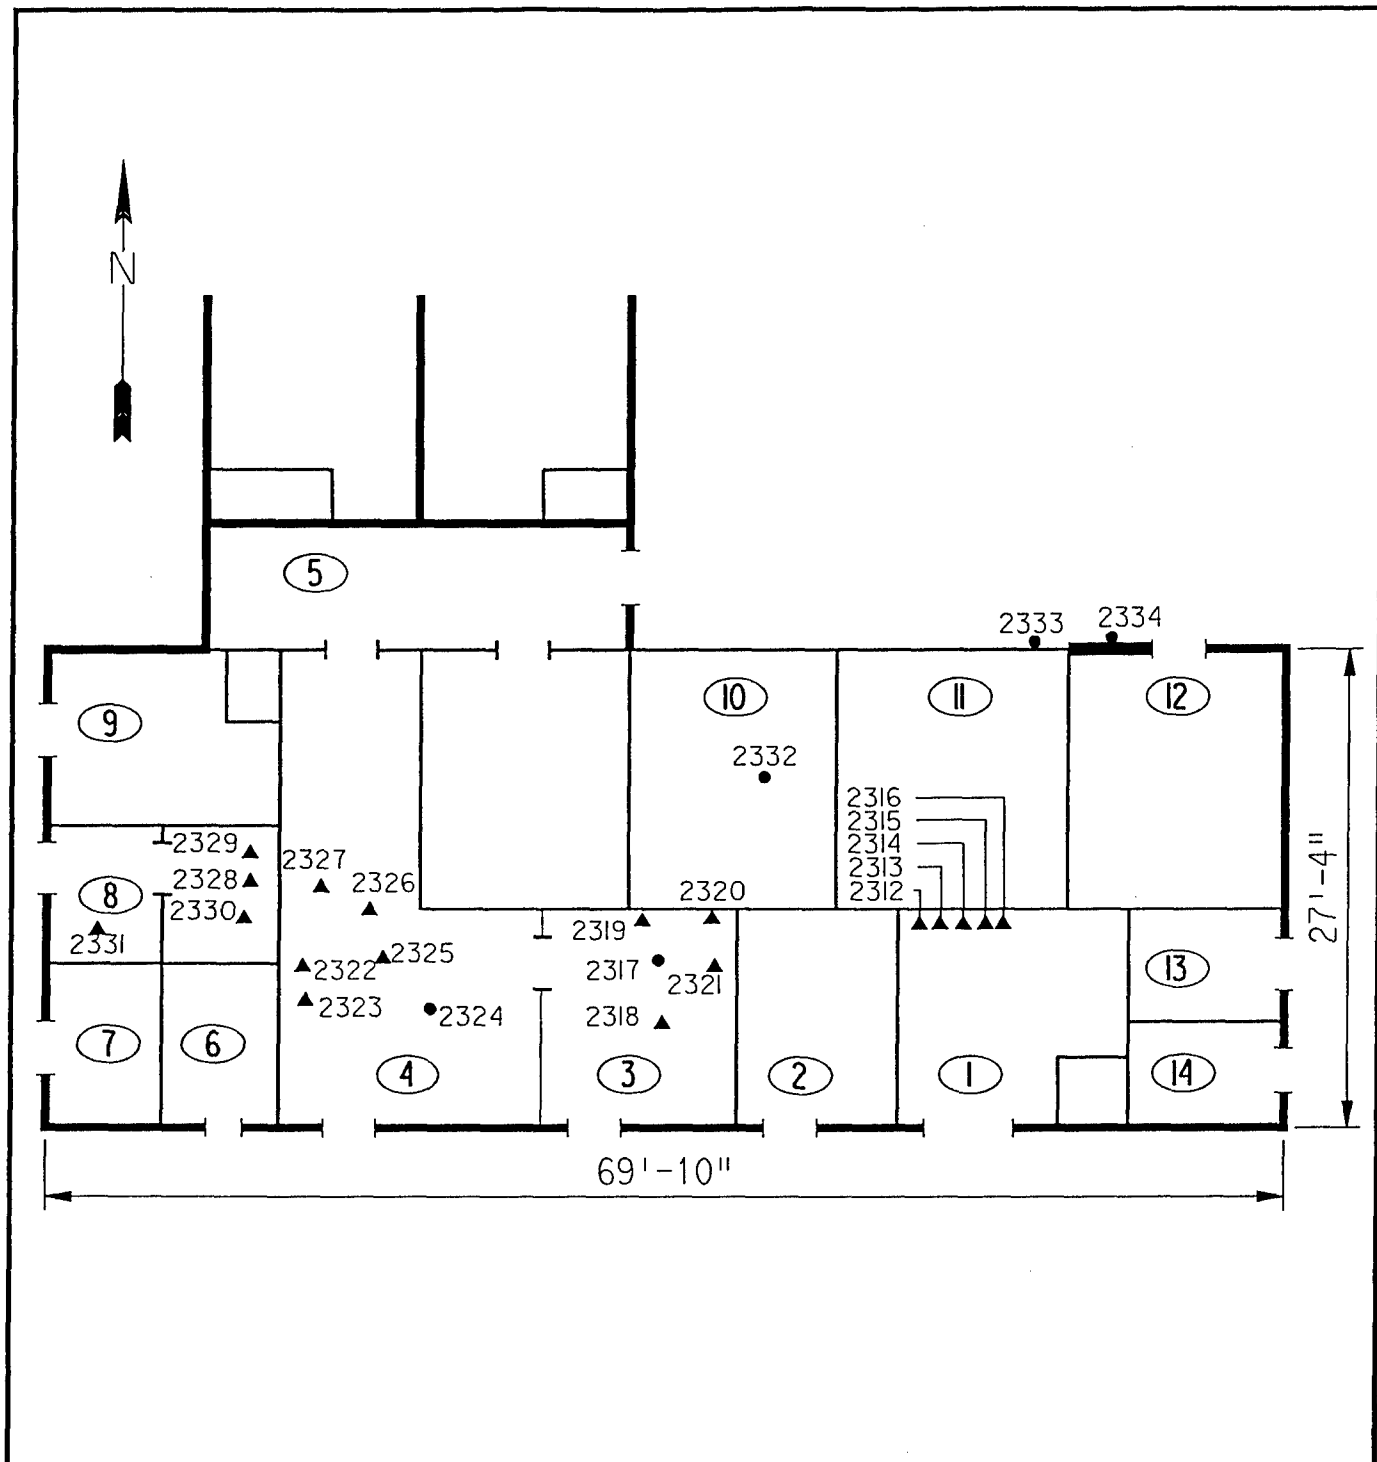
The general condition of ACM present was observed to be poor as described above. Pipe insulations were observed to be friable, while other ACMs were nonfriable. The extensive damage observed indicated that the building is not regularly maintained. The assessment rating was based on the premise that the building was locked and inaccessible even for maintenance activities. The building should be locked and have warning signs posted.

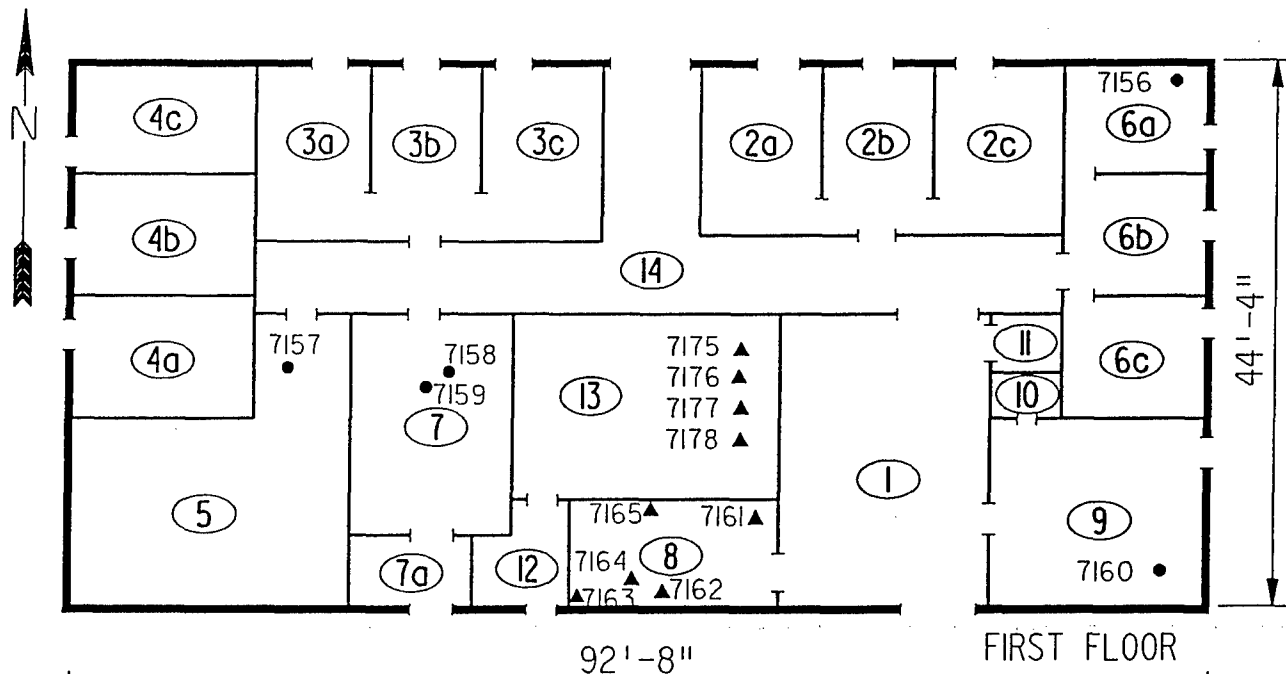
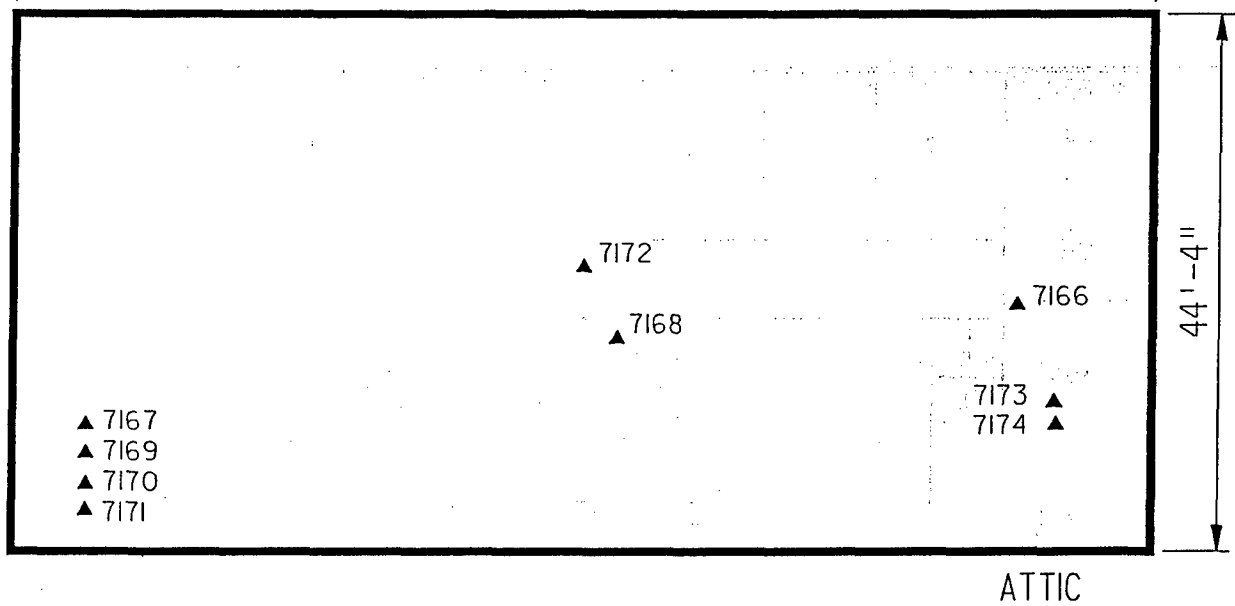
Corrugated cardboard duct insulation observed in Rooms 13 and 15 (the attic) was determined to be ACM and significantly damaged. The pipes of the building's heating-system plumbing are coated with these materials. In nearly every room, these pipes run to overhead heaters with attached fan units. If these units were to be restarted, there could potentially be large amounts of contamination blown throughout the building. At the time of the inspection, the building's heating system was not operational. Quantities of the pipe insulation were estimated at 820 linear feet with 75 mudded fittings. Quantities of duct insulation were estimated at 370 linear feet. Duct insulation was quantified in linear feet, but it should be noted that this insulation is wrapped around a 36-inch high by 24-inch wide rectangular duct. Pipe insulations observed were determined to be ACM and damaged, or significantly damaged in isolated areas. Because these materials are extremely friable, building access should be strictly controlled, including posting of asbestos-specific warning signs, until ACM can be abated and the facility adequately decontaminated. A work permit system, including setting up work reviews and procedures, establishing personnel monitoring and personnel protective equipment requirements, and training all personnel accessing these areas, should be implemented.
